Landscape-geomorphological factors of the development of mudflow centres in the Goychay River basin

Tarikhazer, S., Karimova, E., Kuchinskaya, I. 2024. Landscape-geomorphological factors of the development of mudflow centres in the Goychay River basin. *Baltica*, 37 (1), 47–58. Vilnius. ISSN 1648-858X.

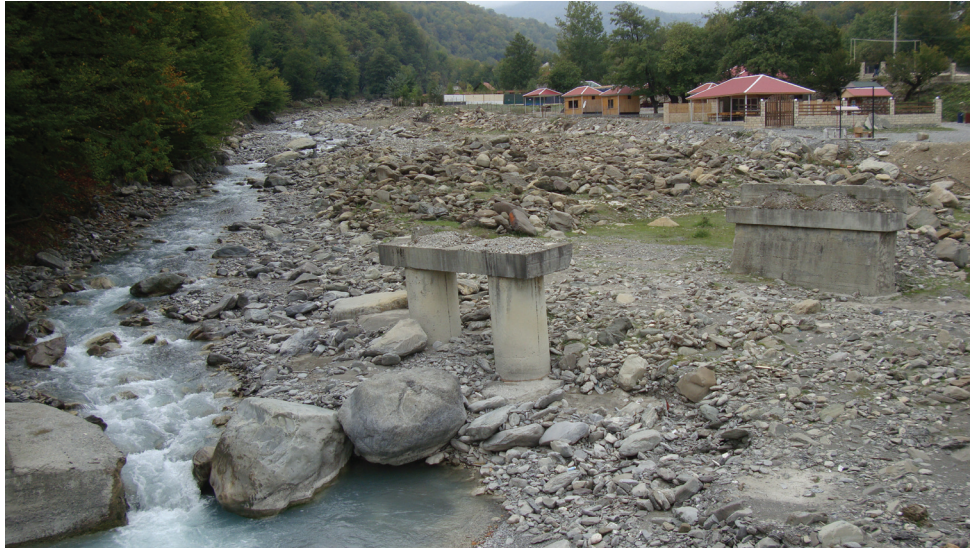
Fig. 1 The bridge over the Shirvanchay River (a tributary of the Goychay River) destroyed on 2 September 2016 by a mudflow in the village of Galajig, Goychay region (photo 12 October 2019)

12.	02.09.2016	In the villages of Istisu, Chaigovushan, Galajig and Sumagalli of the Ismayilli region, damage was caused to sown areas and vegetable gardens. The bridge over the Shirvanchay River (a tributary of the Goychay River) was destroyed (Fig. 1). Poultry died

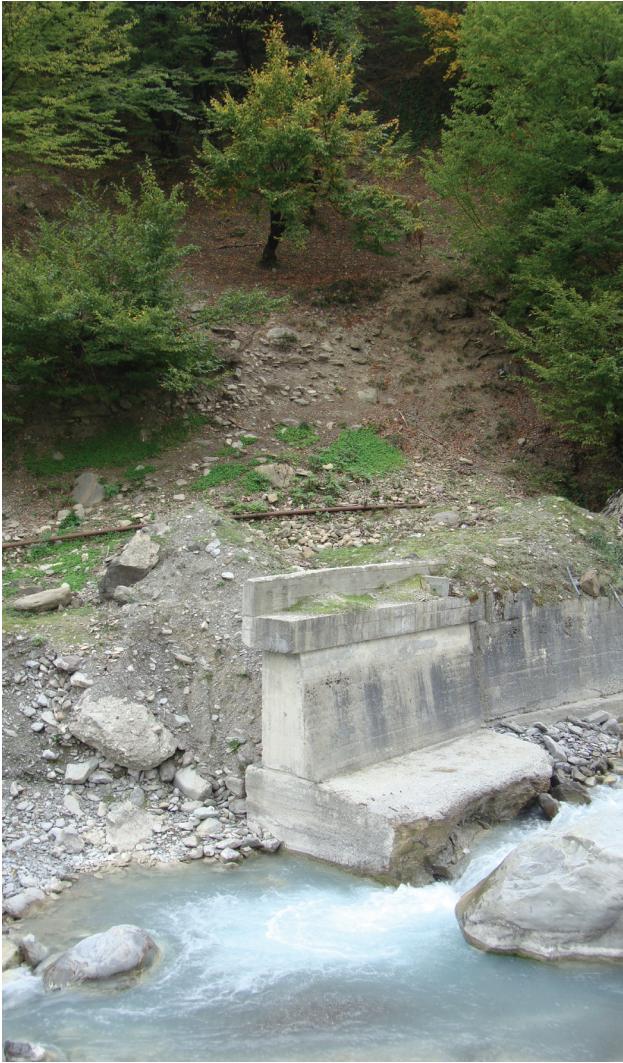
Fig. 3 Landslide processes on the slope of the Goychay River valley (photo 12 October 2019)

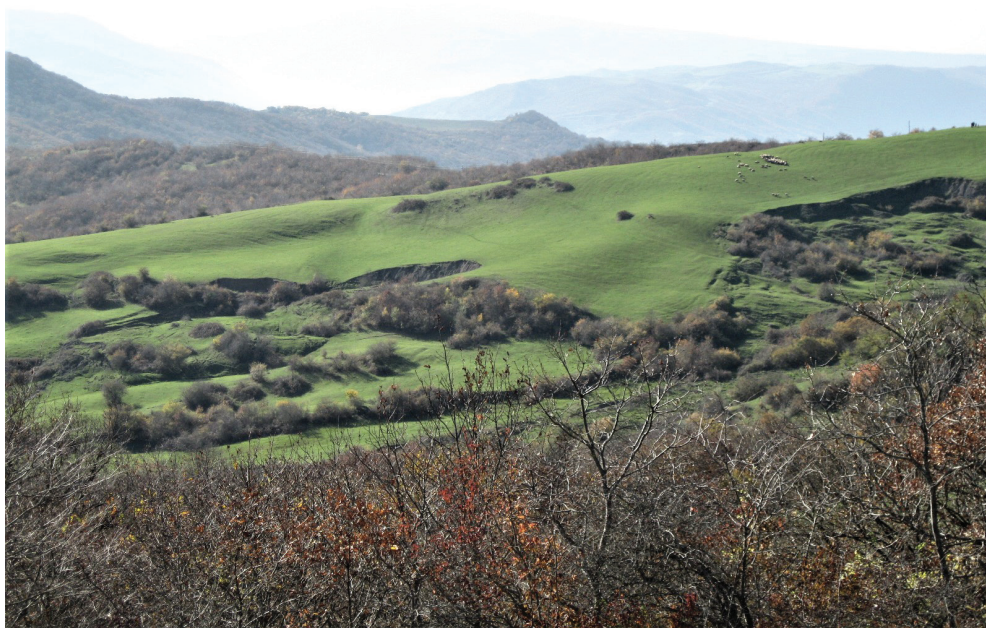
Fig. 4 Typical landslide areas within the mountain-meadow landscape of the Goychay River

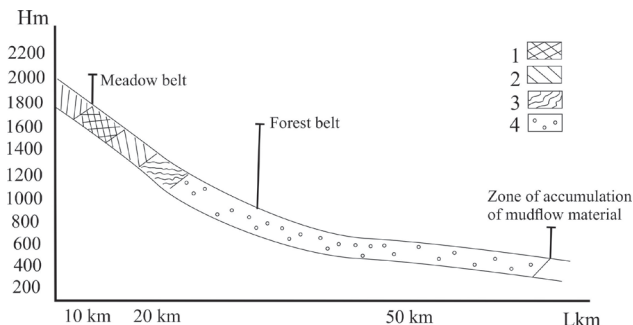
Fig. 6 Geological and geomorphological longitudinal profile of the Goychay River. Meadow belt and mudflow zone: accumulation of materials at the bottom of narrow sections of valleys in the form of deluvial plumes. Forest belt: zone of passage of mudflows, their enrichment with tributary materials and channel sediments

In the plan view, the valley of the Goychay River corresponds to the lines of tectonic faults, along the strike of which the basins are lowered to considerable depths (Figs 5, 6).

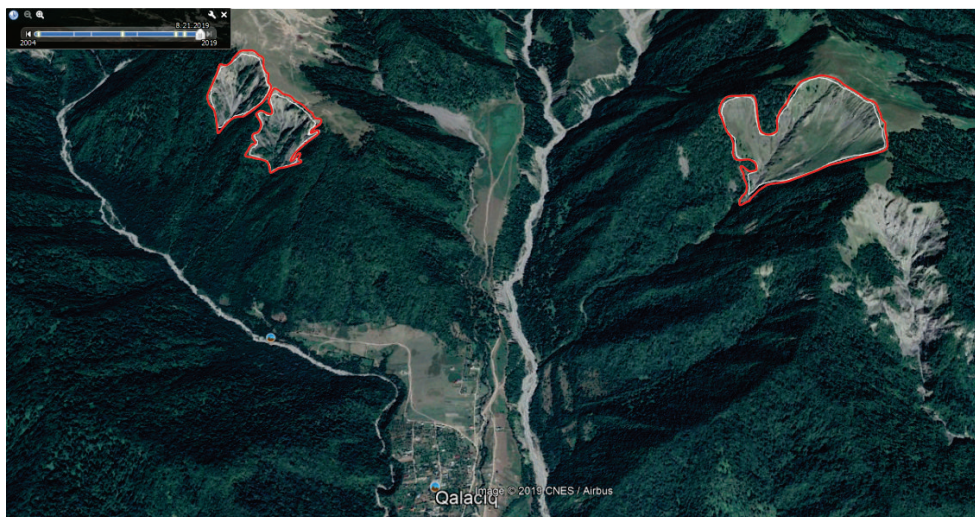
Fig. 7 Mudflows areas of the Goychay River basin and threatening the village of Galajig

Mudflows are predominantly incoherent in nature. All tributaries of the Goychay River are mudflow-bearing. The main mudflow-forming foci of the Goychay River basin are located at an altitude of more than 1800 m in the rocky zone of the basin above the upper border of the forest. However, mudflow centres are also encountered in the forest zone at an altitude of 1500–1800 m. Three large mudflow centres near the Galajig village serve as an example of this (based on the Statistical data for 2019, the population was 1700 people) (Figs 7, 8, 9).

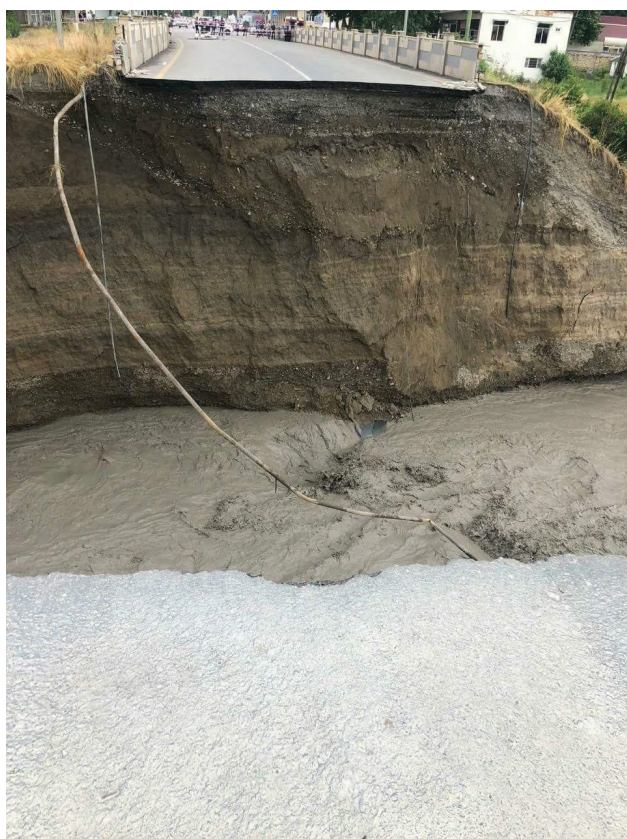
Fig. 8 Bridge destroyed by a mudflow in the Goychay region (photo 2 June 2018)

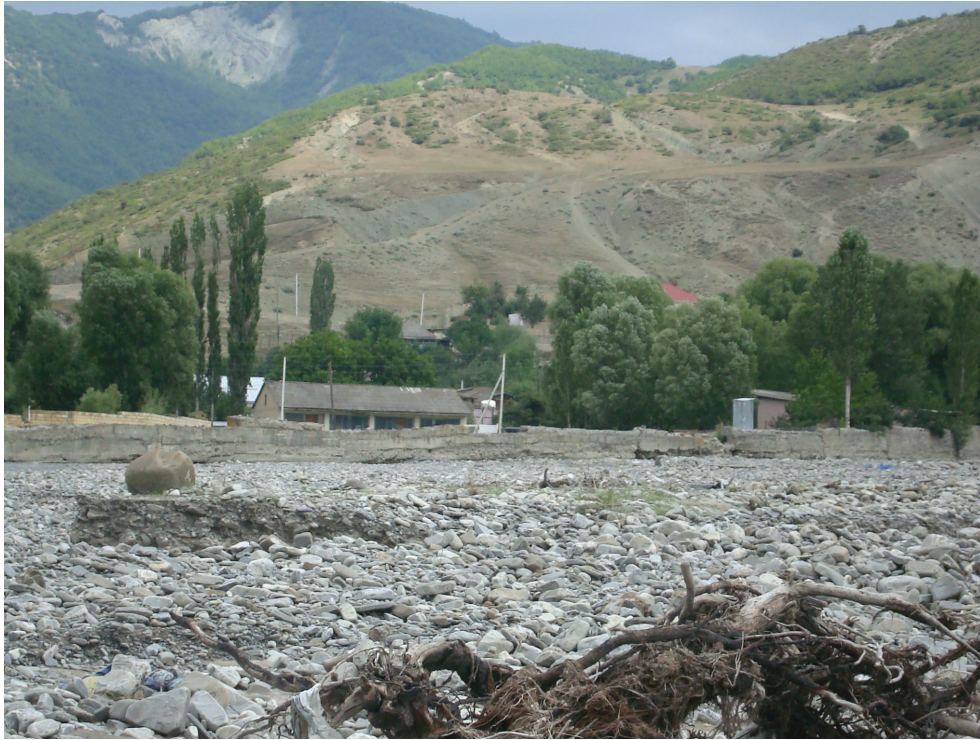
Fig. 9 Goychay River valley after mudflow (photo 2 June 2018)
