Application of aerial photogrammetric technology for determination and parametrization of areas affected by extraction of raw materials

Armanavičius, A., Satkūnas, J. Application of aerial photogrammetric technology for determination and parametrization of areas affected by extraction of raw materials. *Baltica*, 32 (2), 202–209. Vilnius. ISSN 0067-3064. Manuscript submitted 19 July 2019 / Accepted 27 November 2019 / Published online 12 December 2019

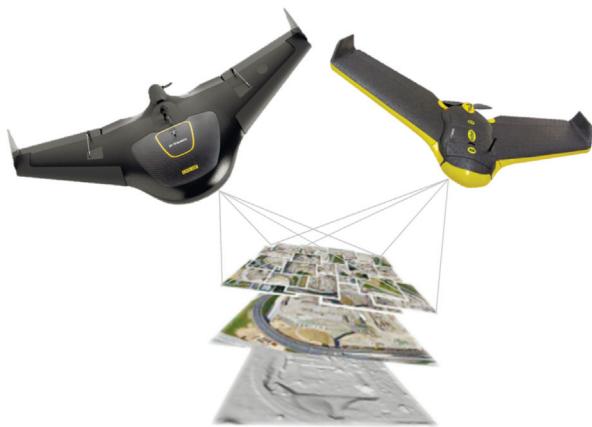
Fig. 4 Drone Trimble UX5 and Sensefly eBee collecting data

probing systems were employed: Sensefly eBee (eBee 2014) and Trimble UX5 (UX5 2016). The base of both systems is a lightweight airplane with a built-in photographic component (Fig. 4).

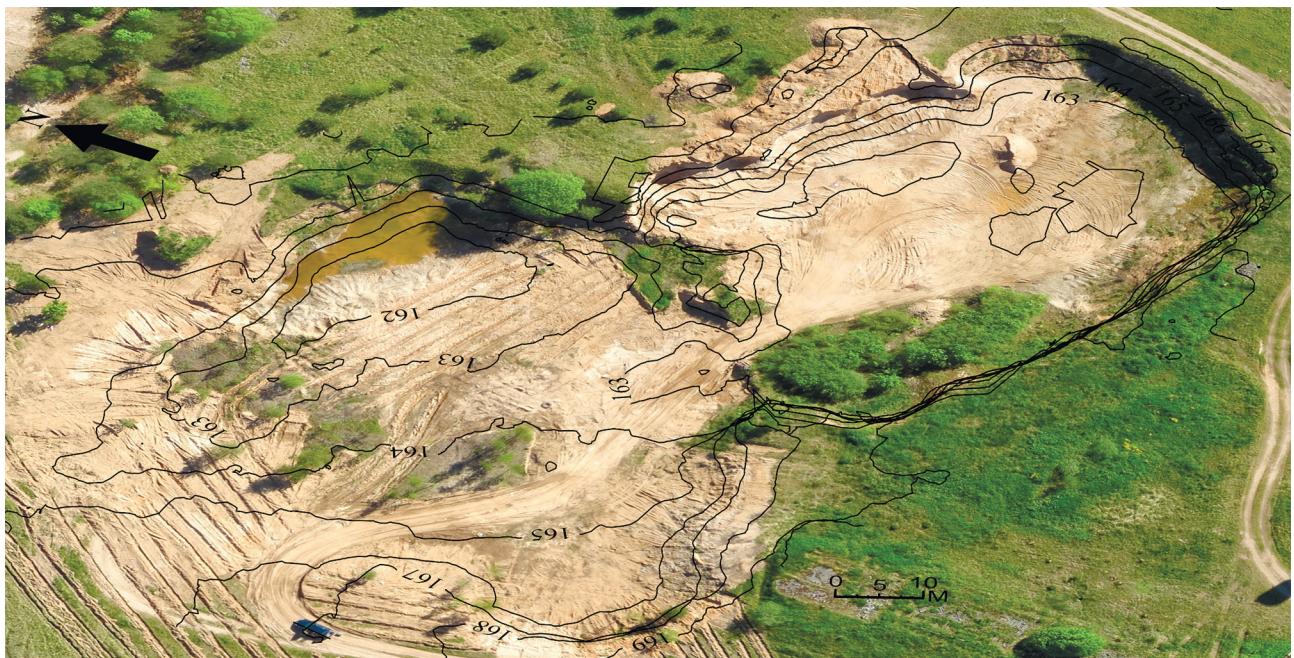
Using software Postflight Terra 3D-EB or Trimble Business Centre 3D, spatial images (models) of the damaged site were created (Fig. 6).
